**Flood Control Project Maintenance
Levee Inspections**

Fall 2019 Levee Maintenance Deficiency Summary Report

Sacramento River Basin

**Flood Control Project Maintenance
Levee Inspections****LMA District Cover Sheet****Fall 2019 Levee Inspection Results****Reclamation District No. 0003 Grand Island**

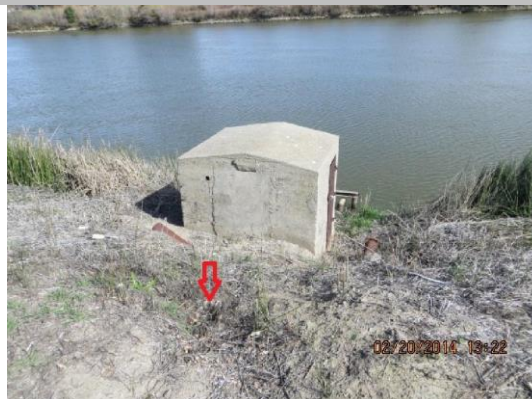
Photo 3 of 3 : UCIP_FA_2019_30648_56412.jpg

Comment Code						
Inspector Comment						
DS_ID:22247						
FS_ID:30648						
EP_NO: 1383						
Repair Type: Non-Urgent						
Crossing Status: Found						
UCIP Comments: 44-inch deep hole on WS slope over pipe 3-inches in diameter.						
FIELD_STRUCT_DESC: 12-inch steel irrigation discharge pipe through the levee, invert elevation 4 feet below the crown. Concrete pump house on the waterside (WS) slope. 5-foot by 7-foot concrete distribution box at the landside (LS) toe with a pole and meter. (Plans for the installation of an irrigation pumping plant and a 12-inch steel discharge pipe through the levee authorized under Permit No. 1383, 1949 - Kate A. Berlin and Frank L. Fallman). [Additional Reference(s): DWR Levee Log, 1993. USACE Sacramento O&M Manual 104, February 1960, (RM 22.33)].						
FS Date: 2/20/2014

Concrete pumphouse on WS shoulder with hole over pipe on WS slope.

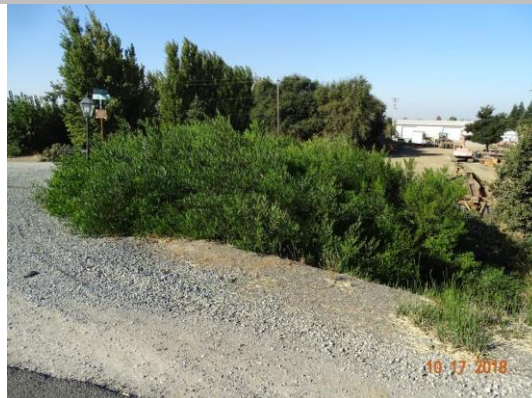
Photo 1 of 1 : FA_2019_RD0003_25_189_20190826_00160.jpg

LM Start	7.43	Rating **	U	Issue No.	189
LM End	7.43	Issue Type +	En	Location *	LS
Category	Earthen Levee			GPS Latitude/Longitude	
				Start	End
Item	Vegetation			38.214308 °	38.214308 °
				-121.558654 °	-121.558654 °
DWR ID	DWR_RD0003_02_s_2018_189				
Comment Code					
V6 : Landscaping					
Inspector Comment

View of landscape vegetation on the landside slope (October 2018).

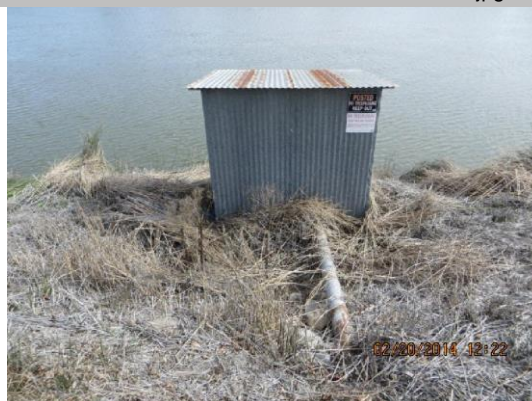
Photo 1 of 3 : UCIP_FA_2019_30643_56402.jpg

Comment Code						
Inspector Comment						
DS_ID:22249						
FS_ID:30643						
EP_NO: N/A						
Repair Type: Non-Urgent						
Crossing Status: Found						
UCIP Comments: Appears abandoned and if so should be done so properly.						
FIELD_STRUCT_DESC: 6-inch steel irrigation discharge pipe through the levee, invert elevation 3.5 feet below the crown. Pump and gate valve in a pump house on the waterside (WS) slope. 36-inch concrete standpipe on the landside (LS). 1.5-inch electrical conduit through the levee at the same location. Power pole and meter on the LS slope. (L. Souza). [Additional Reference(s): DWR Levee Log, 1993. USACE Sacramento O&M Manual 104, February 1960, (RM 22.60)].						
FS Date: 2/20/2014

Pumphouse on WS slope.

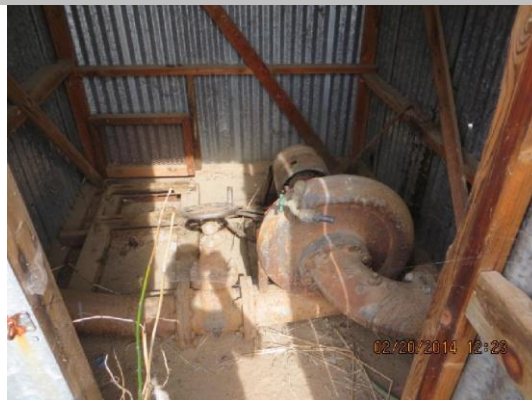
Photo 2 of 3 : UCIP_FA_2019_30643_56401.jpg

Pump, gate valve and pipe visible in pumphouse on WS slope.

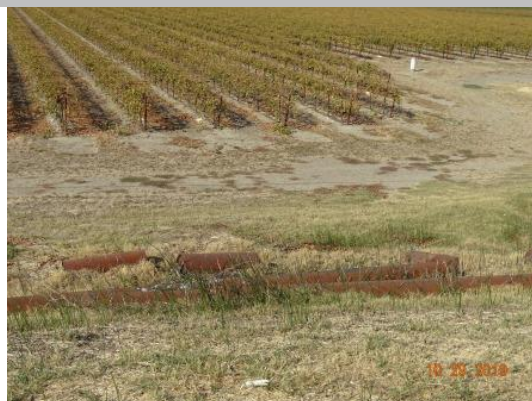
Photo 1 of 1 : FA_2019_RD0003_25_218_20191030_00342.jpg

LM Start	7.85	Rating **	M	Issue No.	218
LM End	7.85	Issue Type +	En	Location *	LS
Category	Earthen Levee			GPS Latitude/Longitude	
				Start	End
Item	Encroachments			38.220437 °	38.220437 °
				-121.558017 °	-121.558017 °
DWR ID	DWR_RD0003_02_f_2019_218				
Comment Code					
GA : Garbage					
Inspector Comment					
Large discarded pipes at this location.

View of large discarded pipes at the bottom of the landside slope (Fall 2019).

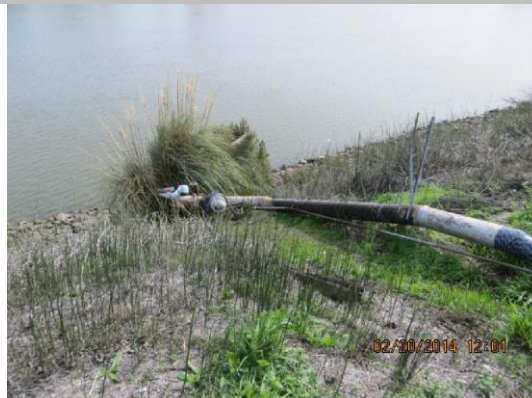
Photo 1 of 2 : UCIP_FA_2019_30623_56381.jpg

DS_ID:22251
FS_ID:30623
EP_NO: 886
Repair Type: Non-Urgent
Crossing Status: Found
UCIP Comments: Erosion under pipe on LS slope.
FIELD_STRUCT_DESC: 10-inch steel irrigation discharge pipe through the levee, invert elevation 3.8 feet below the crown. Slant pump on the waterside (WS) slope. 36-inch concrete standpipe at the landside (LS) toe with a filter plant. Service pole on the LS slope. 1.5-inch steel electrical conduit through the levee at the same location. (Plans for the installation and maintenance of an irrigation pumping plant, including an 8-inch discharge pipe through the levee authorized under Permit No. 886, 1942 - Georgia McKuen. Retention of an irrigation pumping plant with a slant pump and a 10-inch steel pipe through the levee above the floodplain and a service pole near the LS shoulder authorized under Automatic Board Order (ABO) issued as Permit No. 9437, 1974 - Joseph Green Jr. [Additional Reference(s): DWR Levee Log, 1993, 12-inch pipe referenced. USACE Sacramento O&M Manual, February 1960, (RM 22.96)].

Pipe and slant pump on WS slope.

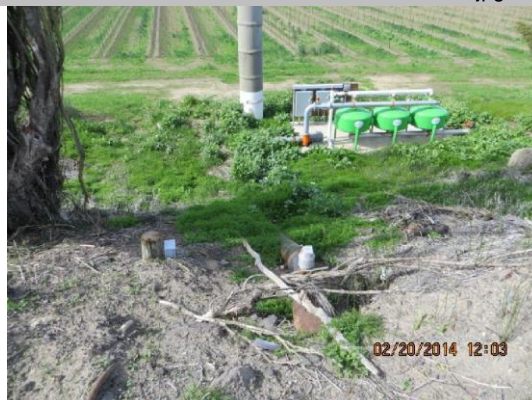
Photo 2 of 2 : UCIP_FA_2019_30623_56380.jpg

vent, pipe, standpipe, and filter plant on LS.

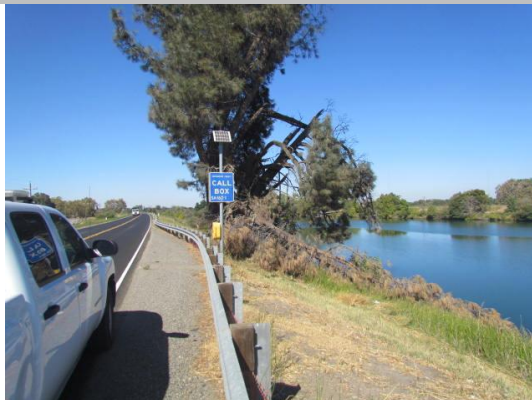
Photo 1 of 2 : FA_2019_RD0003_25_15_20190826_00017.jpg

LM Start	8.11	Rating **	U	Issue No.	15
LM End	8.11	Issue Type +	Ma	Location *	WS
Category	Earthen Levee			GPS Latitude/Longitude	
				Start	End
Item	Encroachments			38.224130°	38.224130°
				-121.557206°	-121.557206°
DWR ID	DWR_RD0003_02_f_2015_15				
Comment Code					
TR : Tree or limb					
Inspector Comment					
Remove broken tree branches on waterside shoulder and slope.

Looking northeast at broken and cracked tree branches on waterward slope.

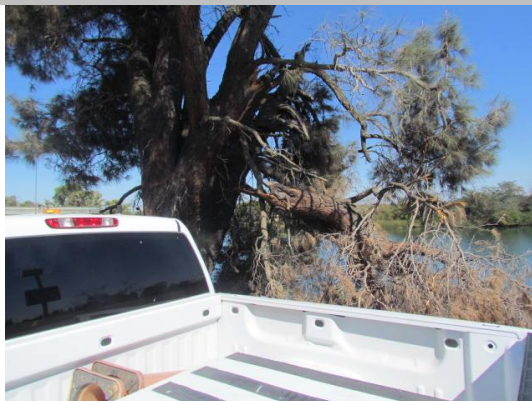
Photo 2 of 2 : FA_2019_RD0003_25_15_20190826_00018.jpg

Looking east at broken and cracked tree branches on waterward slope.

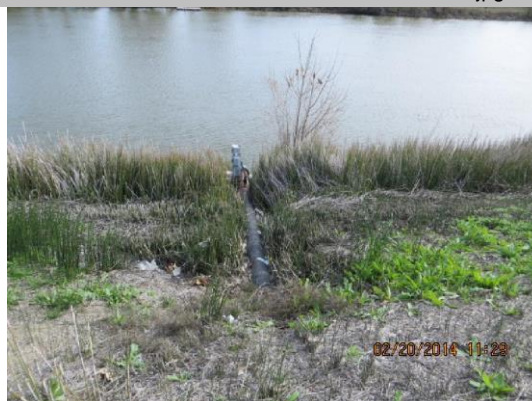
Photo 3 of 3 : UCIP_FA_2019_30577_56346.jpg

Pump and pipe visible on WS slope.

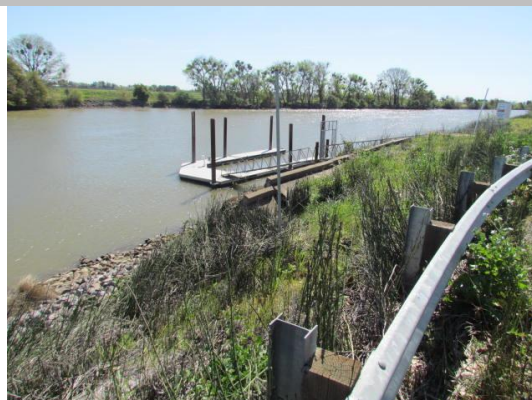
Photo 1 of 1 : FA_2019_RD0003_25_59_20190826_00040.jpg

LM Start	8.43	Rating **	M	Issue No.	59
LM End	8.43	Issue Type +	En	Location *	WS
Category	Earthen Levee			GPS Latitude/Longitude	
				Start	End
Item	Encroachments			38.229251 °	38.229251 °
				-121.557227 °	-121.557227 °
DWR ID	DWR_RD0003_02_s_2012_59				
Comment Code					
MA : Material					
Inspector Comment					
There are concrete footings and retaining walls at the levee toe and slopes. They have been in place for several years.

Looking southeast at concrete structure on waterward slope.

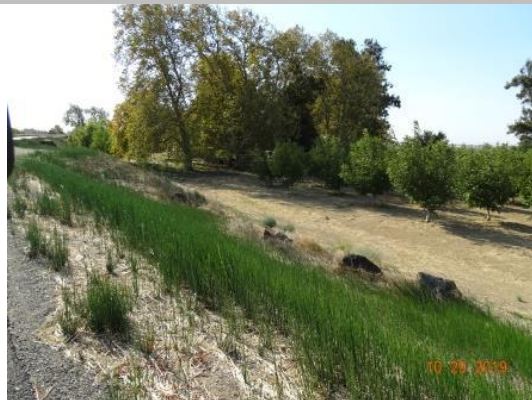
Photo 1 of 1 : FA_2019_RD0003_25_216_20191030_00341.jpg

LM Start	8.54	Rating **	M	Issue No.	216
LM End	8.54	Issue Type +	En	Location *	LS
Category	Earthen Levee			GPS Latitude/Longitude	
				Start	End
Item	Encroachments			38.230332°	38.230332°
				-121.557633°	-121.557633°
DWR ID	DWR_RD0003_02_f_2019_216				
Comment Code					
DE : Debris					
Inspector Comment					
There are large chunks of concrete on the landside.

View looking downstream at large concrete chunks at the bottom of the landside slope (Fall 2019).

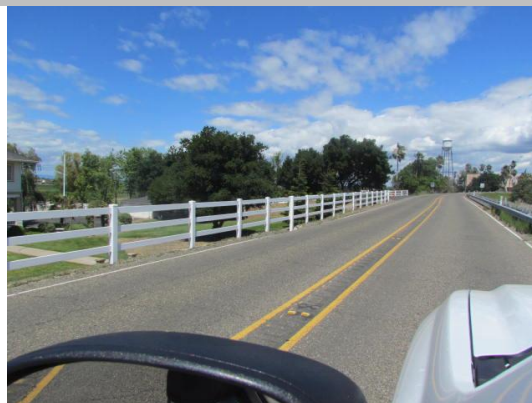
Photo 1 of 1 : FA_2019_RD0003_25_78_20190826_00057.jpg

LM Start	8.85	Rating **	M	Issue No.	78
LM End	8.93	Issue Type +	En	Location *	LS
Category	Earthen Levee			GPS Latitude/Longitude	
				Start	End
Item	Encroachments			38.234516 °	38.235630 °
				-121.559502 °	-121.559640 °
DWR ID	DWR_RD0003_02_s_2013_78				
Comment Code					
FE : Fence					
Inspector Comment					
There is an unauthorized fence along this stretch.

Looking northwest at unauthorized fence on landward shoulder.

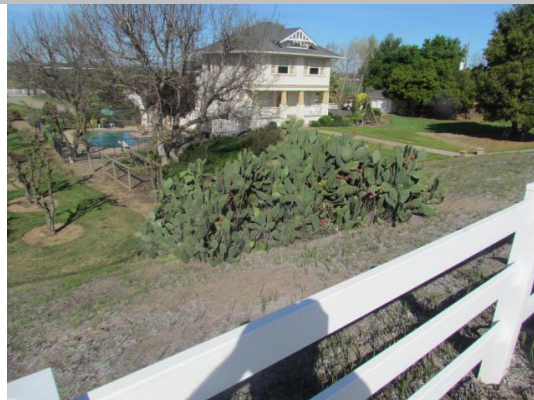
Photo 1 of 1 : FA_2019_RD0003_25_158_20190826_00142.jpg

LM Start	8.87	Rating **	U	Issue No.	158
LM End	8.87	Issue Type +	En	Location *	LS
Category	Earthen Levee			GPS Latitude/Longitude	
				Start	End
Item	Vegetation			38.234759 °	38.234759 °
				-121.559534 °	-121.559534 °
DWR ID	DWR_RD0003_02_s_2015_158				
Comment Code					
V6 : Landscaping					
Inspector Comment					
There is a large cluster of cactus on the landside slope.

Looking west at cactus on landward slope and toe.

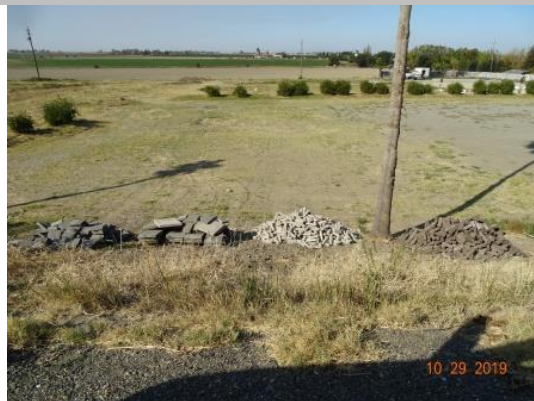
Photo 1 of 1 : FA_2019_RD0003_25_215_20191030_00340.jpg

LM Start	8.99	Rating **	M	Issue No.	215
LM End	8.99	Issue Type +	En	Location *	LS
Category	Earthen Levee			GPS Latitude/Longitude	
				Start	End
Item	Encroachments			38.236508 °	38.236508 °
				-121.559543 °	-121.559543 °
DWR ID	DWR_RD0003_02_f_2019_215				
Comment Code					
MA : Material					
Inspector Comment					
Piles of concrete tiles at the landside toe.

View of piles of concrete tiles at the landside toe (Fall 2019).

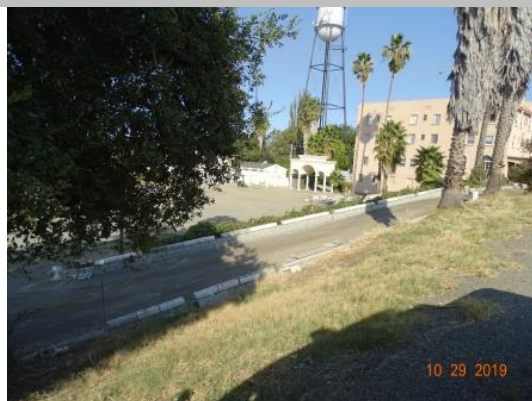
Photo 1 of 1 : FA_2019_RD0003_25_2_20191030_00339.jpg

LM Start	9.01	Rating **	M	Issue No.	2
LM End	9.01	Issue Type +	En	Location *	LS
Category	Earthen Levee			GPS Latitude/Longitude	
				Start	End
Item	Encroachments			38.236877 °	38.236877 °
				-121.559528 °	-121.559528 °
DWR ID	DWR_RD0003_02_s_2012_2				
Comment Code					
RA : Ramp					
Inspector Comment					
Landowner installed an unauthorized ramp on the landside slope. The district engineer has spoken with the landowner about removing the ramp. Wild grape vines are growing on the ramp slope.

View looking upstream at unauthorized ramp on the landside (Fall 2019).

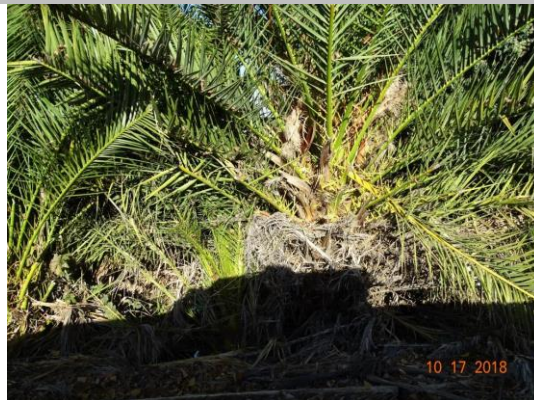
Photo 1 of 1 : FA_2019_RD0003_25_182_20190826_00157.jpg

LM Start	9.16	Rating **	U	Issue No.	182
LM End	9.16	Issue Type +	En	Location *	LS
Category	Earthen Levee			GPS Latitude/Longitude	
				Start	End
Item	Vegetation			38.238812 °	38.238812 °
				-121.558187 °	-121.558187 °
DWR ID	DWR_RD0003_02_f_2018_182				
Comment Code					
V6 : Landscaping					
Inspector Comment					
Palm trees are blocking the view of the levee.

View of palm trees at the top of the landside slope (October 2018).

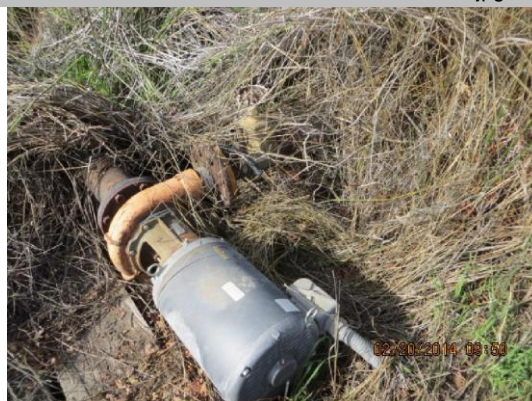
Photo 2 of 3 : UCIP_FA_2019_30507_56119.jpg

Comment Code						
Inspector Comment						
DS_ID:22271 FS_ID:30507 EP_NO: 3295 Repair Type: Non-Urgent Crossing Status: Found UCIP Comments: Possibly Abandoned and if so should be done properly. Pipe shows sigs of decay on LS toe and there is pipe debris on the WS slope. Good candidate for video inspection. FIELD_STRUCT_DESC: 10-inch steel irrigation discharge pipe through the levee, 6.5 feet below the crown. Pump on the waterside (WS) slope with a gate valve. Gate valve, power pole, and meter visible on the landside (LS) toe. 1.5-inch steel electrical conduit through the levee at the same location. (Plans for installation of a pump and motor on the WS slope of the levee and installation of an 8-inch pipe through an existing 12-inch pipe through the levee authorized under Permit No. 3295, 1960 - Robert and Craig James). [Additional Reference(s): DWR Levee Log, 1993]. FS Date: 2/20/2014

Pump and gate valve on WS slope.

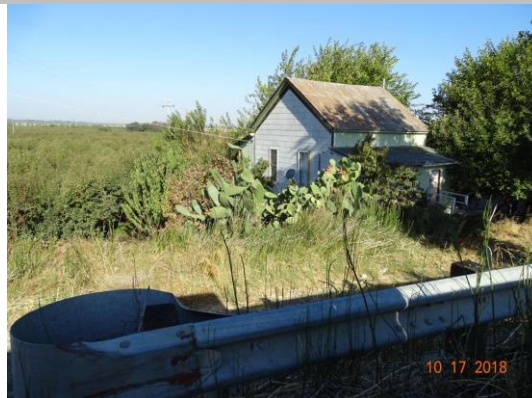
Photo 1 of 1 : FA_2019_RD0003_25_100_20190826_00078.jpg

LM Start	9.35	Rating **	M	Issue No.	100
LM End	9.37	Issue Type +	En	Location *	LS
Category	Earthen Levee			GPS Latitude/Longitude	
				Start	End
Item	Vegetation			38.240997 °	38.241199 °
				-121.556136 °	-121.555867 °
DWR ID	DWR_RD0003_02_f_2013_100				
Comment Code					
V6 : Landscaping					
Inspector Comment					
There is cactus located on the landside slope. Palm trees have been removed.

View of cactus on the landside slope (October 2018).

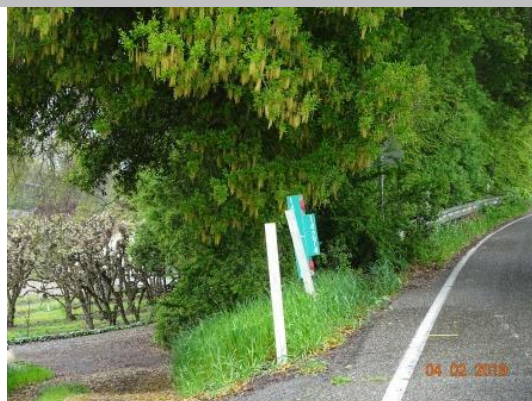
Photo 1 of 1 : FA_2019_RD0003_25_175_20190826_00154.jpg

LM Start	9.43	Rating **	U	Issue No.	175
LM End	9.45	Issue Type +	En	Location *	LS
Category	Earthen Levee			GPS Latitude/Longitude	
				Start	End
Item	Vegetation			38.241752 °	38.241902 °
				-121.555088 °	-121.554792 °
DWR ID	DWR_RD0003_02_f _ 2018_175				
Comment Code					
V6 : Landscaping					
Inspector Comment					
Trim landscaping trees to allow view down the landside slope.

View looking upstream at landscape vegetation on the landside slope (Spring 2019).

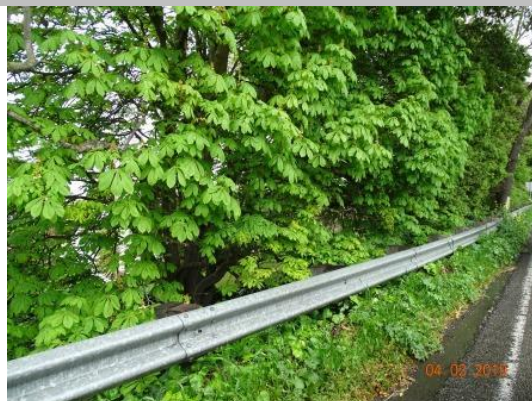
Photo 1 of 1 : FA_2019_RD0003_25_186_20190826_00159.jpg

LM Start	9.47	Rating **	U	Issue No.	186
LM End	9.49	Issue Type +	En	Location *	LS
Category	Earthen Levee			GPS Latitude/Longitude	
				Start	End
Item	Vegetation			38.242031°	38.242110°
				-121.554326°	-121.554047°
DWR ID	DWR_RD0003_02_s_2019_186				
Comment Code					
V6 : Landscaping					
Inspector Comment					
Trim landscape vegetation on the landside slope.

View looking upstream at landscaping on the landside slope (Spring 2019).

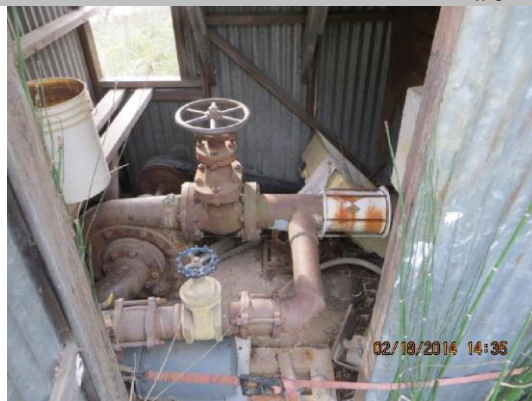
Photo 1 of 3 : UCIP_FA_2019_31349_57435.jpg

Comment Code						
Inspector Comment						
DS_ID:22275 FS_ID:31349 EP_NO: 3738 Repair Type: Non-Urgent Crossing Status: Found UCIP Comments: Heavy foliage over pipe and appurtances on LS slope. FIELD_STRUCT_DESC: 6-inch steel irrigation discharge pipe through the levee, invert elevation 5.5 feet below the crown. Pump and gate valve in a pump house on the waterside (WS) slope. 1.5-inch steel electrical conduit through the levee at the same location. (Plans to insert a new 4-inch pipe through an existing 6-inch irrigation pipe through the levee authorized under Permit No. 3738, 1961 - Emmett James). [Additional Reference(s): DWR Levee Log, 1993. USACE Sacramento O&M Manual 104, February 1960, (RM 24.48)]. FS Date: 2/18/2014

Pump, pipe, and gate valves in pumphouse on WS slope.

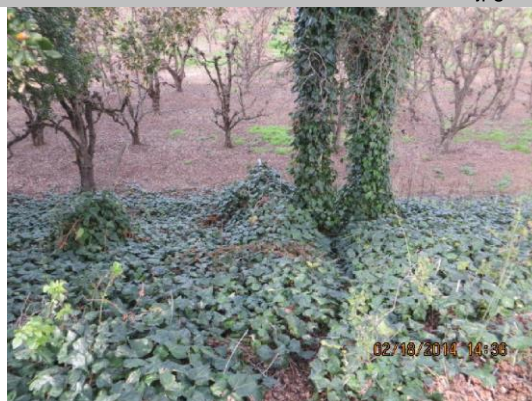
Photo 3 of 3 : UCIP_FA_2019_31349_57433.jpg

Comment Code						
Inspector Comment						
DS_ID:22275 FS_ID:31349 EP_NO: 3738 Repair Type: Non-Urgent Crossing Status: Found UCIP Comments: Heavy foliage over pipe and appurtances on LS slope. FIELD_STRUCT_DESC: 6-inch steel irrigation discharge pipe through the levee, invert elevation 5.5 feet below the crown. Pump and gate valve in a pump house on the waterside (WS) slope. 1.5-inch steel electrical conduit through the levee at the same location. (Plans to insert a new 4-inch pipe through an existing 6-inch irrigation pipe through the levee authorized under Permit No. 3738, 1961 - Emmett James). [Additional Reference(s): DWR Levee Log, 1993. USACE Sacramento O&M Manual 104, February 1960, (RM 24.48)]. FS Date: 2/18/2014

Pipe visible at LS toe.

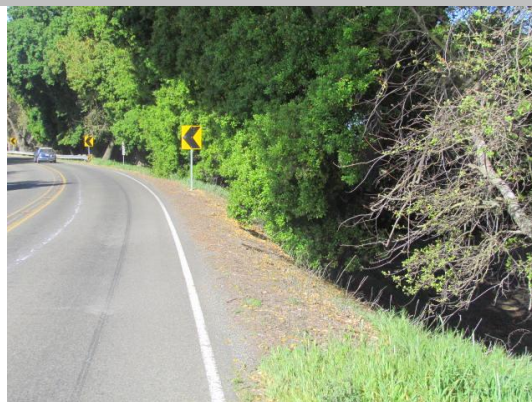
Photo 1 of 1 : FA_2019_RD0003_25_64_20190826_00043.jpg

LM Start	9.56	Rating **	M	Issue No.	64
LM End	9.62	Issue Type +	Ma	Location *	LS
Category	Earthen Levee			GPS Latitude/Longitude	
				Start	End
Item	Trim / Thin Trees			38.242392 °	38.242501 °
				-121.552862 °	-121.551632 °
DWR ID	DWR_RD0003_02_s_2012_64				
Comment Code					
T1 : Trim trees to at least five feet above ground level.					
Inspector Comment

Looking southwest at dense trees on landward shoulder and slope.

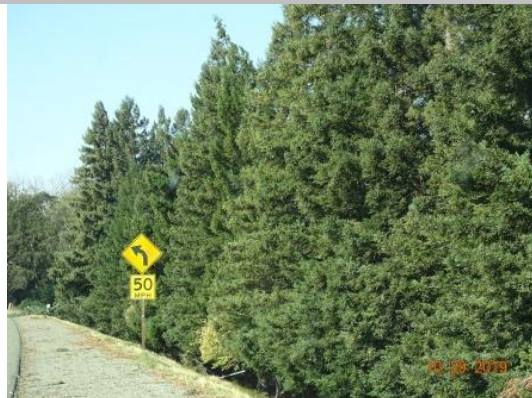
Photo 1 of 1 : FA_2019_RD0003_25_101_20191030_00338.jpg

LM Start	9.63	Rating **	U	Issue No.	101
LM End	9.77	Issue Type +	En	Location *	LS
Category	Earthen Levee			GPS Latitude/Longitude	
				Start	End
Item	Vegetation			38.242471°	38.242251°
				-121.551426°	-121.548970°
DWR ID	DWR_RD0003_02_f_2013_101				
Comment Code					
V6 : Landscaping					
Inspector Comment					
Large redwood trees at the landside toe.

View looking downstream at redwood trees at the landside toe (Fall 2019).

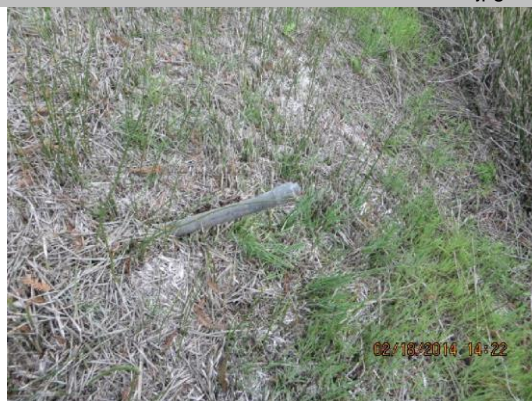
Photo 1 of 1 : UCIP_FA_2019_30424_55960.jpg

DS_ID:22277
FS_ID:30424
EP_NO: N/A
Repair Type: Non-Urgent
Crossing Status: Found
UCIP Comments: Pipe is not grouted properly.
FIELD_STRUCT_DESC: *ABANDONED* 14-inch steel irrigation discharge pipe through the levee, 5.7 feet below the crown. (Pipe capped on both ends by USACE in 1964). 1.5-inch steel electrical conduit through the levee at the same location, visible on both sides of the levee and capped. [Additional Reference(s): DWR Levee Log, 1993].
FS Date: 2/18/2014

Electrical conduit visible on WS slope.

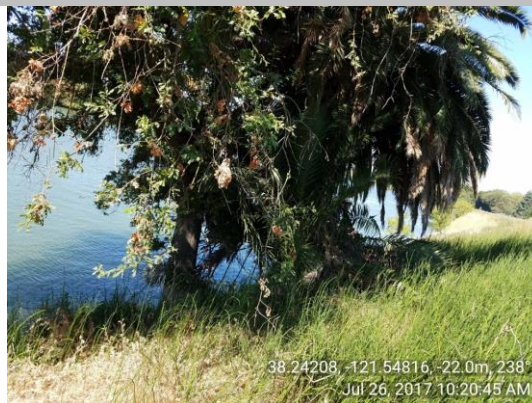
Photo 1 of 3 : FA_2019_RD0003_25_137_20190826_00107.jpg

Levee Evaluation Comments
Description: District station 518+55 to 519+81, Sec. 33, T. 5 N. R. 4 E., M.D.M. Approximately 126 linear feet of erosion and sloughing exists along the water side slope of the Sacramento River (Unit 2). The erosion commences approximately 1/4 of the way down the slope from the crown and extends into the rip rap.
Site ID No: 279
Site Designation: LMA-105
Repair Type: Erosion
Rating: Area of Concern
Field Date: 7/26/2017
Notes:

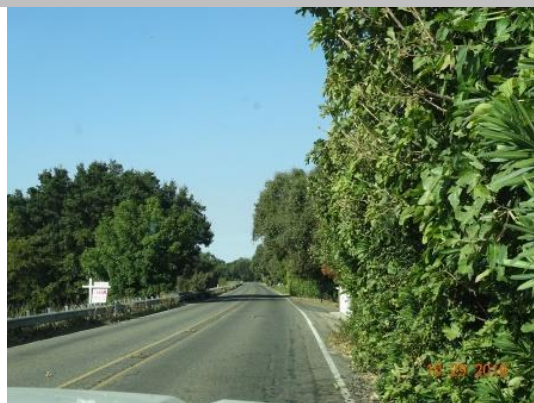
Photo 1 of 1 : FA_2019_RD0003_25_156_20191030_00337.jpg

LM Start	9.85	Rating **	U	Issue No.	156
LM End	9.97	Issue Type +	En	Location *	LS
Category	Earthen Levee			GPS Latitude/Longitude	
				Start	End
Item	Vegetation			38.242068°	38.241798°
				-121.547423°	-121.545394°
DWR ID	DWR_RD0003_02_s_2015_156				
Comment Code					
V6 : Landscaping					
Inspector Comment

View looking downstream at landscaping on the landside shoulder (Fall 2019).

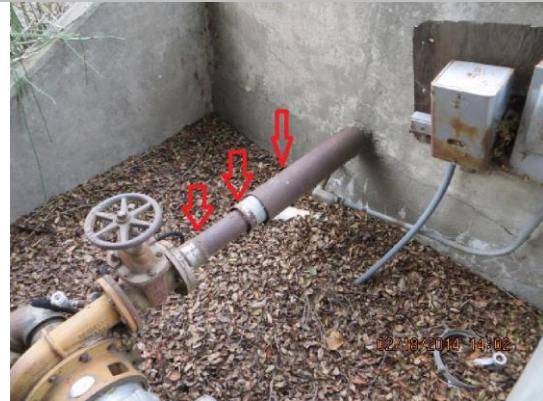
Photo 2 of 3 : UCIP_FA_2019_30408_55930.jpg

Comment Code						
Inspector Comment						
DS_ID:22280 FS_ID:30408 EP_NO: N/A Repair Type: Non-Urgent Crossing Status: Found UCIP Comments: Annular space not grouted. FIELD_STRUCT_DESC: 6-inch steel irrigation discharge pipe through the levee, invert elevation 5.5 feet below the crown. A 3.5-inch steel pipe is sleeved through a 5-inch pipe which is sleeved through the 6-inch pipe. The annular space is not grouted. Pump and gate valve on the waterside (WS) slope. Concrete distribution box at the landside (LS) toe. 1.5-inch electrical conduit through the levee at the same location. Service pole at the LS toe. (Joe Dianda). [Additional Reference(s): DWR Levee Log, 1993. USACE Sacramento O&M Manual 104, February 1960, (RM 24.88)]. FS Date: 2/18/2014

2 pipes sleeved through 6-inch pipe.

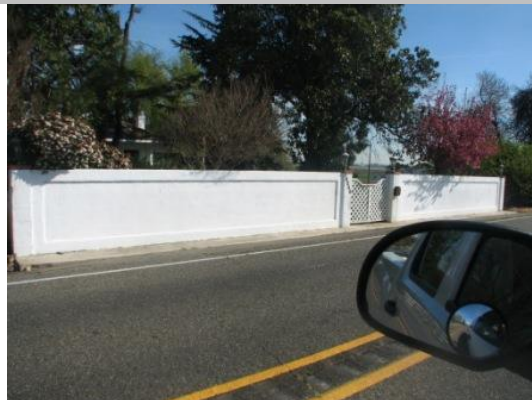
Photo 1 of 1 : FA_2019_RD0003_25_19_20190826_00020.jpg

LM Start	9.93	Rating **	U	Issue No.	19
LM End	9.93	Issue Type +	En	Location *	LS
Category	Earthen Levee			GPS Latitude/Longitude	
				Start	End
Item	Encroachments			38.241880 °	38.241880 °
				-121.546108 °	-121.546108 °
DWR ID	DWR_RD0003_02_s_2012_19				
Comment Code					
FE : Fence					
Inspector Comment

Block/Concrete fence on landside shoulder.

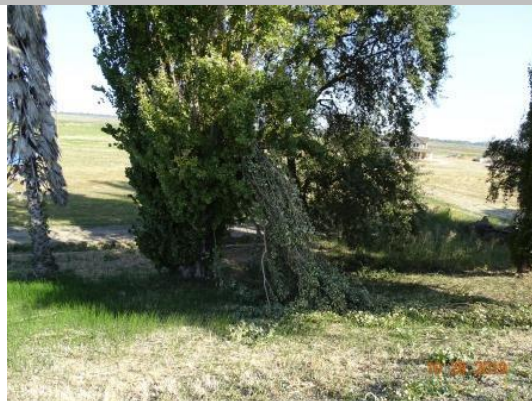
Photo 1 of 1 : FA_2019_RD0003_25_212_20191030_00336.jpg

LM Start	10.00	Rating **	M	Issue No.	212
LM End	10.00	Issue Type +	Ma	Location *	LS
Category	Earthen Levee			GPS Latitude/Longitude	
				Start	End
Item	Trim / Thin Trees			38.241710 °	38.241710 °
				-121.544858 °	-121.544858 °
DWR ID	DWR_RD0003_02_f_2019_212				
Comment Code					
T2 : Thin trees to allow visibility of the ground and room to flood fight.					
Inspector Comment					
Remove broken limb from slope.

View of broken tree limb on the landside slope (Fall 2019).

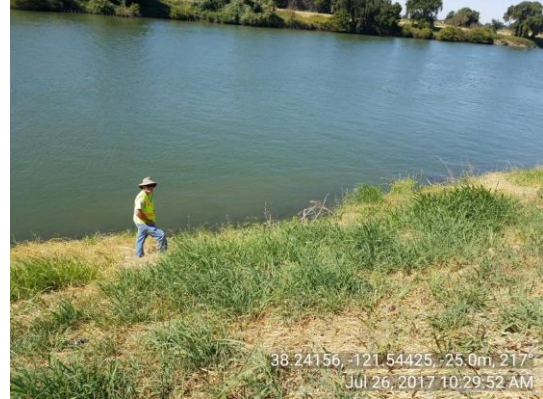
Photo 1 of 3 : FA_2019_RD0003_25_138_20190826_00110.jpg

LM Start	10.01	Rating **	A/W	Issue No.	138
LM End	10.03	Issue Type +	Ma	Location *	WS
Category	Supplemental			GPS Latitude/Longitude	
				Start	End
Item	2017 Storm Damage			38.241481 °	38.241439 °
				-121.544569 °	-121.544353 °
DWR ID	LMA-106				
Comment Code					
Inspector Comment					
Levee Evaluation Comments					
Description: District station 528+97 to 529+58, Sec. 33, T. 5 N. R. 4 E., M.D.M. Approximately 61 linear feet of erosion and sloughing exists along the water side slope of the Sacramento River (Unit 2). The erosion commences approximately 1/2 of the way down the slope from the crown and extends into the rip rap.					
Site ID No: 280					
Site Designation: LMA-106					
Repair Type: Erosion					
Rating: Area of Concern					
Field Date: 7/26/2017					
Notes:

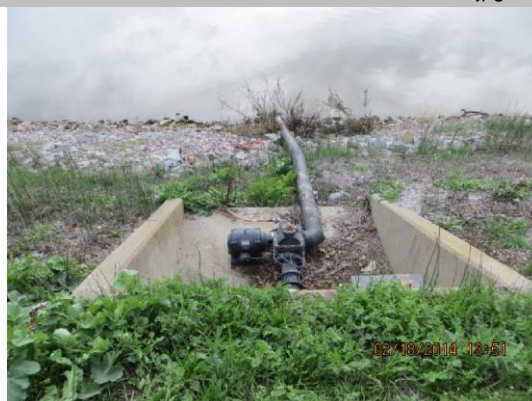
Photo 1 of 3 : UCIP_FA_2019_30406_55927.jpg

Comment Code						
Inspector Comment						
DS_ID:22281						
FS_ID:30406						
EP_NO: N/A						
Repair Type: Non-Urgent						
Crossing Status: Found						
UCIP Comments: Actuator for Gate valve is broken off.						
FIELD_STRUCT_DESC: 8-inch steel irrigation discharge pipe through the levee, invert elevation 6.5 feet below the crown. Pipe reduced to 6 inches on the slopes. Pump and gate valve on a concrete pad on the waterside (WS) slope. Siphon breaker on the landside (LS) slope. (DWR Bank Protection Project, Drawing No. 50-4-3741, Sheet 21 - Castanho). [Additional Reference(s): DWR Levee Log, 1993. USACE Sacramento O&M Manual 104, February 1960, (RM 25.09), 6-inch pipe referenced].						
FS Date: 2/18/2014

Pump, gate valve, and concrete pad on WS slope.

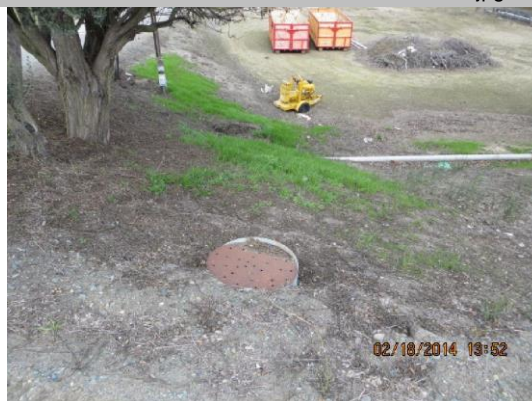
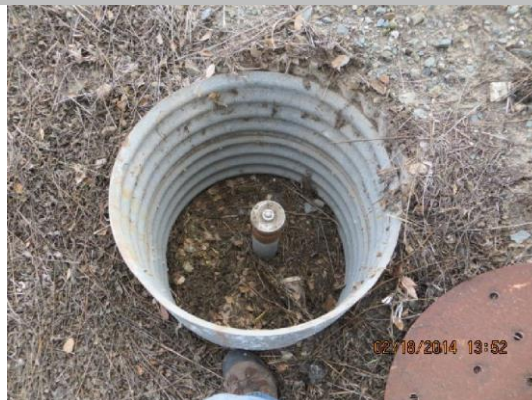
Item	DRAFT DWR UCIP Field Study			38.241300 °	38.241300 °	
				-121.542967 °	-121.542967 °	
DWR ID	22281					
Comment Code						
Inspector Comment						
DS_ID:22281						
FS_ID:30406						
EP_NO: N/A						
Repair Type: Non-Urgent						
Crossing Status: Found						
UCIP Comments: Actuator for Gate valve is broken off.						
FIELD_STRUCT_DESC: 8-inch steel irrigation discharge pipe through the levee, invert elevation 6.5 feet below the crown. Pipe reduced to 6 inches on the slopes. Pump and gate valve on a concrete pad on the waterside (WS) slope. Siphon breaker on the landside (LS) slope. (DWR Bank Protection Project, Drawing No. 50-4-3741, Sheet 21 - Castanho). [Additional Reference(s): DWR Levee Log, 1993. USACE Sacramento O&M Manual 104, February 1960, (RM 25.09), 6-inch pipe referenced].						
FS Date: 2/18/2014

Siphon Breaker in CMP riser on LS shoulder.

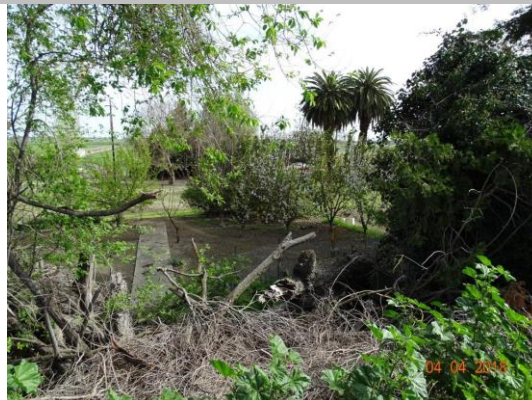
Photo 1 of 1 : FA_2019_RD0003_25_170_20190826_00152.jpg

LM Start	10.15	Rating **	U	Issue No.	170
LM End	10.15	Issue Type +	Ma	Location *	LS
Category	Earthen Levee			GPS Latitude/Longitude	
				Start	End
Item	Encroachments			38.241125 °	38.241125 °
				-121.542075 °	-121.542075 °
DWR ID	DWR_RD0003_02_s_2018_170				
Comment Code					
TR : Tree or limb					
Inspector Comment					
There is a fallen tree on the landside slope.

Fallen tree on landside slope.

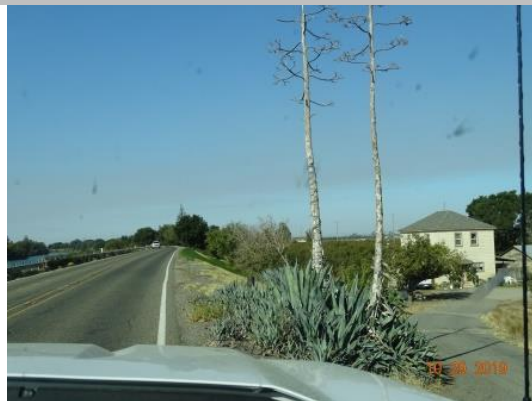
Photo 1 of 1 : FA_2019_RD0003_25_81_20191030_00334.jpg

LM Start	10.43	Rating **	M	Issue No.	81
LM End	10.43	Issue Type +	En	Location *	LS
Category	Earthen Levee			GPS Latitude/Longitude	
				Start	End
Item	Vegetation			38.239850 °	38.239850 °
				-121.537237 °	-121.537237 °
DWR ID	DWR_RD0003_02_s_2013_81				
Comment Code					
V6 : Landscaping					
Inspector Comment					
There is a century plant on the landside shoulder.

View looking downstream at century plants on the landside slope (Fall 2019).

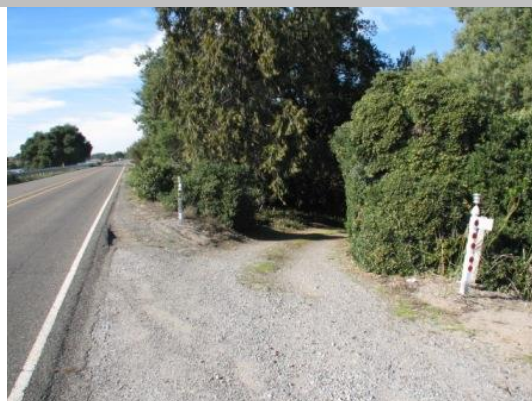
Photo 1 of 1 : FA_2019_RD0003_25_66_20190826_00044.jpg

LM Start	10.53	Rating **	U	Issue No.	66
LM End	10.53	Issue Type +	En	Location *	LS
Category	Earthen Levee			GPS Latitude/Longitude	
				Start	End
Item	Vegetation			38.239462 °	38.239462 °
				-121.535462 °	-121.535462 °
DWR ID	DWR_RD0003_02_s_2012_66				
Comment Code					
V6 : Landscaping					
Inspector Comment

Landscaping on levee slope and toe obstructs access and visibility.

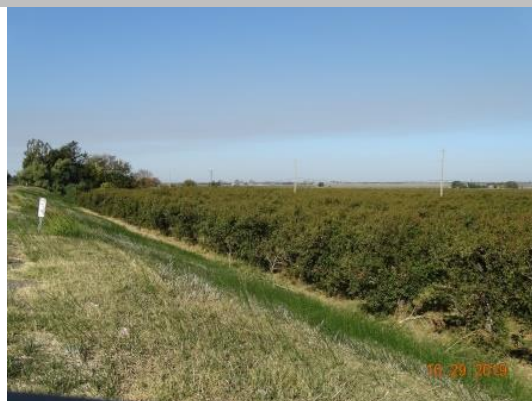
Photo 1 of 1 : FA_2019_RD0003_25_210_20191030_00333.jpg

LM Start	10.56	Rating **	M	Issue No.	210
LM End	10.65	Issue Type +	En	Location *	LS
Category	Earthen Levee			GPS Latitude/Longitude	
				Start	End
Item	Encroachments			38.239375 °	38.239038 °
				-121.534992 °	-121.533290 °
DWR ID	DWR_RD0003_02_f_2019_210				
Comment Code					
CR : Crops					
Inspector Comment					
Pear trees at landside toe.

View looking downstream of pear trees at the landside toe (Fall 2019).

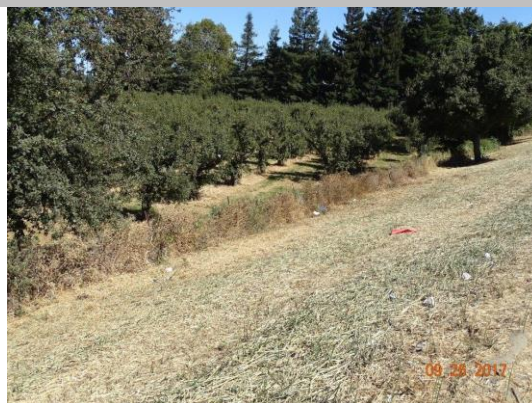
Photo 1 of 1 : FA_2019_RD0003_25_174_20190826_00153.jpg

LM Start	10.69	Rating **	M	Issue No.	174
LM End	10.69	Issue Type +	En	Location *	LS
Category	Earthen Levee			GPS Latitude/Longitude	
				Start	End
Item	Encroachments			38.238921 °	38.238921 °
				-121.532573 °	-121.532573 °
DWR ID	DWR_RD0003_02_f_2017_174				
Comment Code					
FE : Fence					
Inspector Comment					
There is a barbed wire fence at the landside toe blocking access.

Looking northeast at the landside slope.

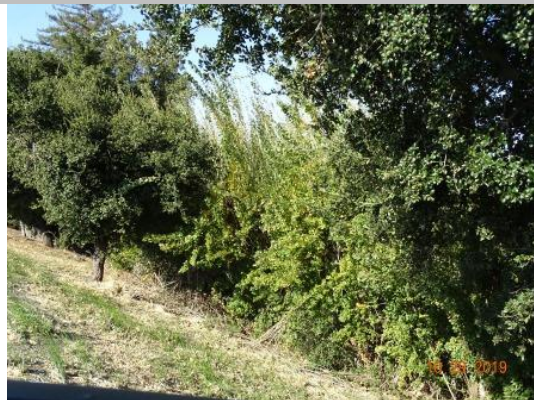
Photo 1 of 1 : FA_2019_RD0003_25_68_20191030_00332.jpg

LM Start	10.74	Rating **	U	Issue No.	68
LM End	10.94	Issue Type +	En	Location *	LS
Category	Earthen Levee			GPS Latitude/Longitude	
				Start	End
Item	Vegetation			38.238788 °	38.239140 °
				-121.531698 °	-121.528085 °
DWR ID	DWR_RD0003_02_s_2012_68				
Comment Code					
V6 : Landscaping					
Inspector Comment					
Row of closely-spaced trees at landside toe inhibits inspection and prevents access.

View looking downstream at closely packed trees at the landside toe (Fall 2019).

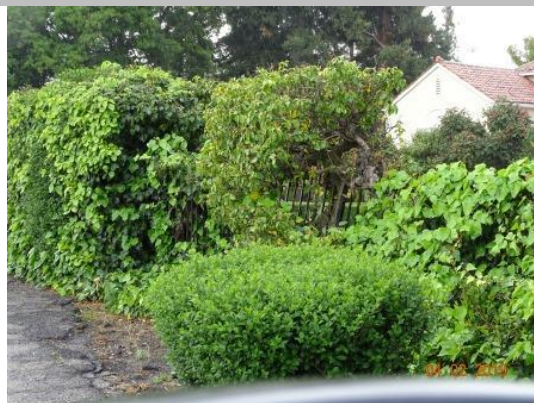
Photo 1 of 1 : FA_2019_RD0003_25_183_20190826_00158.jpg

LM Start	10.75	Rating **	U	Issue No.	183
LM End	10.79	Issue Type +	En	Location *	LS
Category	Earthen Levee			GPS Latitude/Longitude	
				Start	End
Item	Encroachments			38.238772 °	38.238753 °
				-121.531523 °	-121.530789 °
DWR ID	DWR_RD0003_02_s_2019_183				
Comment Code					
FE : Fence					
Inspector Comment					
There is a wrought iron fence on the landside.

View of wrought iron fence on the landside shoulder (Spring 2019).

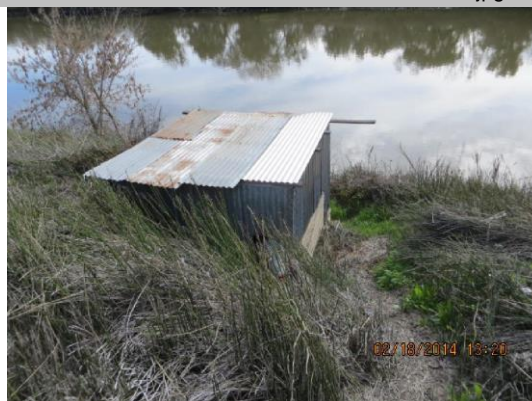
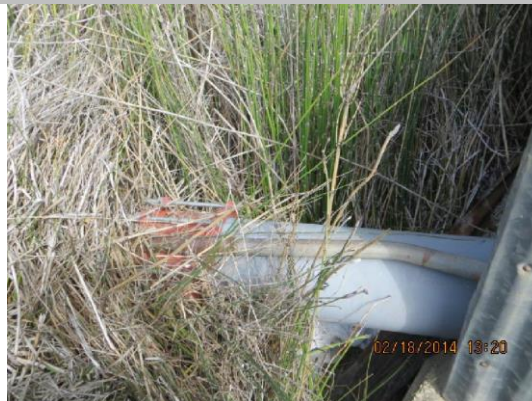
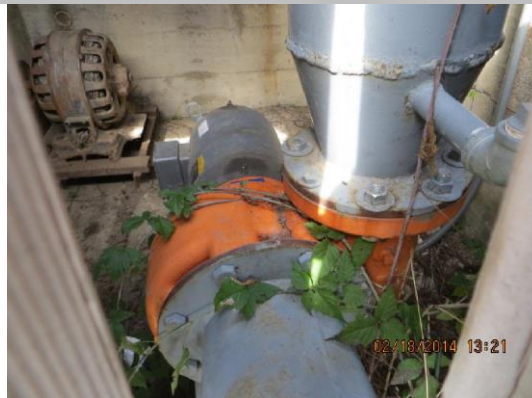
Comment Code					
Inspector Comment					
DS_ID:22284 FS_ID:30391 EP_NO: 9442 Repair Type: Non-Urgent Crossing Status: Found UCIP Comments: Good candidate for video inspection. FIELD_STRUCT_DESC: 8-inch steel irrigation discharge pipe through the levee, invert elevation 7.5 feet below the crown. Pump and gate valve on the waterside (WS) slope. 4-foot by 4-foot concrete distribution box at the landside (LS) toe, next to a power pole and meter. 1.5-inch electrical conduit through the levee at the same location. (Retention of an irrigation pumping plant, centrifugal pump, and accessories in a corrugated metal shed on the WS levee slope and an 8-inch pipe through the levee above the floodplain authorized under Automatic Board Order (ABO) issued as Permit No. 9442, 1974 - Frank Gwerder). [Additional Reference(s): DWR Levee Log, 1993. USACE Sacramento O&M Manual 104, February 1960, (RM 25.74), 6-inch pipe referenced]. FS Date: 2/18/2014

Pump and gate valve in pumphouse on WS slope.

Pipe and conduit visible on WS slope.

Pump in pumphouse on WS slope.

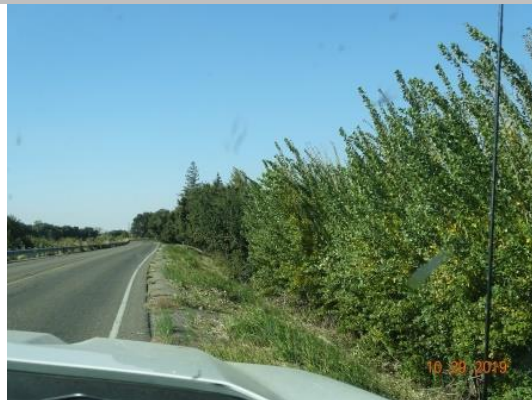
Photo 1 of 1 : FA_2019_RD0003_25_160_20191030_00331.jpg

LM Start	10.90	Rating **	U	Issue No.	160
LM End	11.08	Issue Type +	En	Location *	LS
Category	Earthen Levee			GPS Latitude/Longitude	
				Start	End
Item	Vegetation			38.238962 °	38.239706 °
				-121.528842 °	-121.525707 °
DWR ID	DWR_RD0003_02_s_2018_160				
Comment Code					
V6 : Landscaping					
Inspector Comment					
Row of closely-spaced trees at landside toe inhibits inspection and prevents access.

View looking downstream at closely packed trees at the landside toe (Fall 2019).

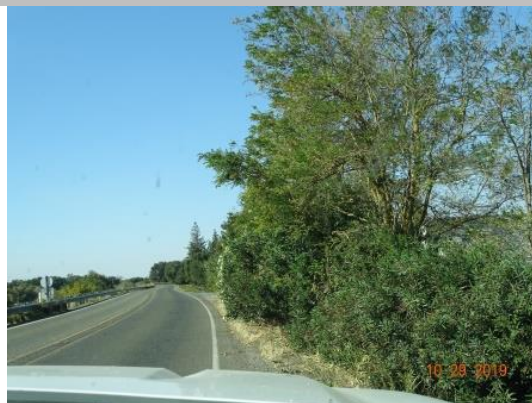
Photo 1 of 1 : FA_2019_RD0003_25_84_20191030_00330.jpg

LM Start	11.10	Rating **	U	Issue No.	84
LM End	11.10	Issue Type +	En	Location *	LS
Category	Earthen Levee			GPS Latitude/Longitude	
				Start	End
Item	Vegetation			38.239730 °	38.239730 °
				-121.525190 °	-121.525190 °
DWR ID	DWR_RD0003_02_s_2013_84				
Comment Code					
V6 : Landscaping					
Inspector Comment

View looking downstream at landscaping on the landside slope (Fall 2019).

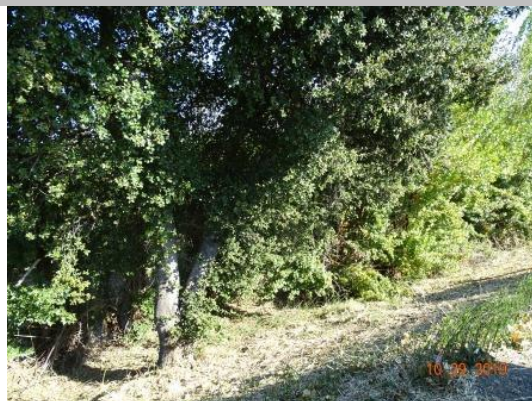
Photo 1 of 1 : FA_2019_RD0003_25_153_20191030_00329.jpg

LM Start	11.13	Rating **	U	Issue No.	153
LM End	11.13	Issue Type +	En	Location *	LS
Category	Earthen Levee			GPS Latitude/Longitude	
				Start	End
Item	Vegetation			38.239858 °	38.239858 °
				-121.524747 °	-121.524747 °
DWR ID	DWR_RD0003_02_s_2018_153				
Comment Code					
V6 : Landscaping					
Inspector Comment					
Row of closely-spaced trees at landside toe inhibits inspection and prevents access.

View looking slightly upstream at closely packed trees at the landside toe (Fall 2019).

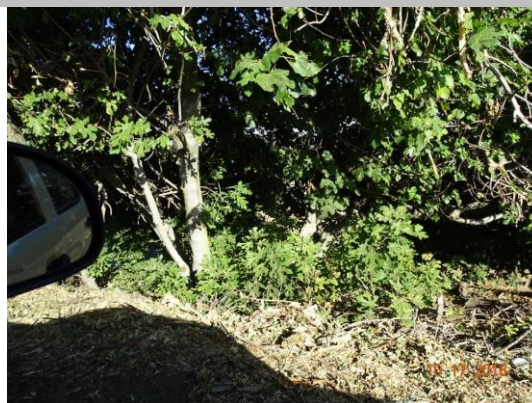
Photo 1 of 1 : FA_2019_RD0003_25_148_20190826_00127.jpg

LM Start	11.21	Rating **	U	Issue No.	148
LM End	11.21	Issue Type +	Ma	Location *	LS
Category	Earthen Levee			GPS Latitude/Longitude	
				Start	End
Item	Trim / Thin Trees			38.239968 °	38.239968 °
				-121.523293 °	-121.523293 °
DWR ID	DWR_RD0003_02_f_2018_148				
Comment Code					
T1 : Trim trees to at least five feet above ground level.					
Inspector Comment					
Trim fig trees that are sprouting.

View of newly sprouting fig trees on the landside slope (October 2018).

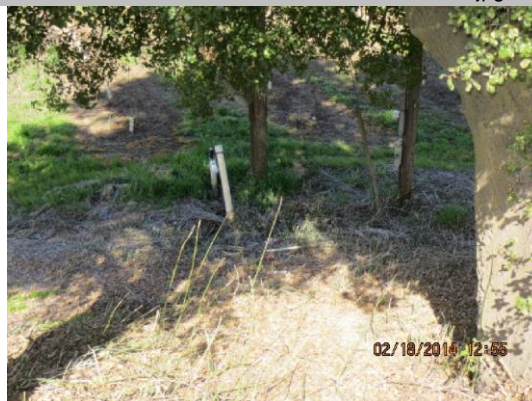
LM Start	11.25	Rating **	M	Issue No.	983
LM End	11.25	Issue Type +	En	Location *	
Category	Supplemental			GPS Latitude/Longitude	
				Start	End
Item	DRAFT DWR UCIP Field Study			38.239992 °	38.239992 °
				-121.522463 °	-121.522463 °
DWR ID	22288				
Comment Code					
Inspector Comment					
DS_ID:22288 FS_ID:30364 EP_NO: N/A Repair Type: Non-Urgent Crossing Status: Found UCIP Comments: Annular space not grouted. FIELD_STRUCT_DESC: 8-inch steel irrigation discharge pipe through the levee, invert elevation 6.7 feet below the crown. A 4-inch polyvinyl chloride (PVC) pipe is sleeved through the 8-inch pipe. Pump and gate valve in a pump house on the waterside (WS) slope. (Johnson). [Additional Reference(s): DWR Levee Log, 1993. USACE Sacramento O&M Manual 104, February 1960, (RM 26.25)]. FS Date: 2/18/2014

PVC pipe, pole, and meter visible on LS toe.

Shutoff valve at pump on WS slope.

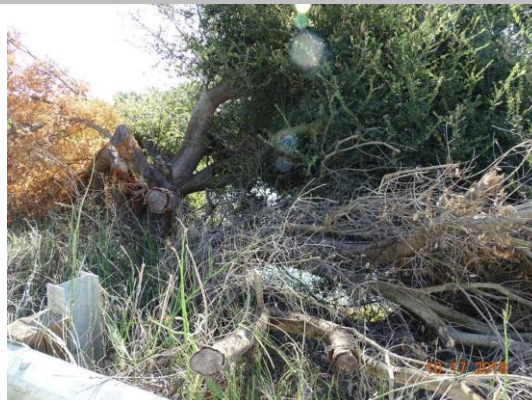
Photo 1 of 1 : FA_2019_RD0003_25_201_20190826_00167.jpg

LM Start	11.26	Rating **	U	Issue No.	201
LM End	11.26	Issue Type +	Ma	Location *	WS
Category	Earthen Levee			GPS Latitude/Longitude	
				Start	End
Item	Encroachments			38.240012 °	38.240012 °
				-121.522418 °	-121.522418 °
DWR ID	DWR_RD0003_02_f_2018_201				
Comment Code					
TR : Tree or limb					
Inspector Comment					
Remove fallen tree limbs from the waterside slope.

View of fallen tree that has been chopped up on the waterside slope (October 2018).

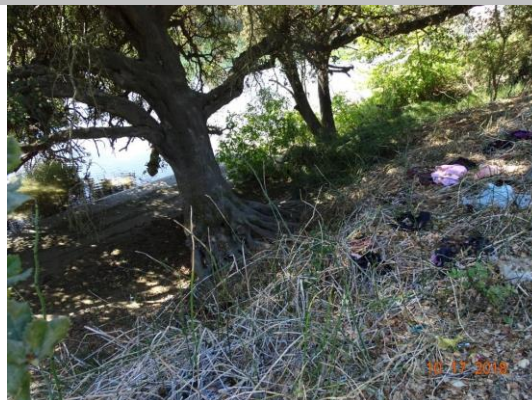
Photo 1 of 1 : FA_2019_RD0003_25_168_20191206_00356.jpg

LM Start	11.37	Rating **	M	Issue No.	168
LM End	11.37	Issue Type +	Ob	Location *	WS
Category	Earthen Levee			GPS Latitude/Longitude	
				Start	End
Item	Erosion / Bank Caving			38.240140 °	38.240140 °
				-121.520310 °	-121.520310 °
DWR ID	DWR_RD0003_02_f_2019_168				
Comment Code					
E2 : Schedule repair of erosion site prior to the next inspection.					
Inspector Comment					
Pocket of erosion into waterside toe

View of erosion at the waterside toe (October 2018).

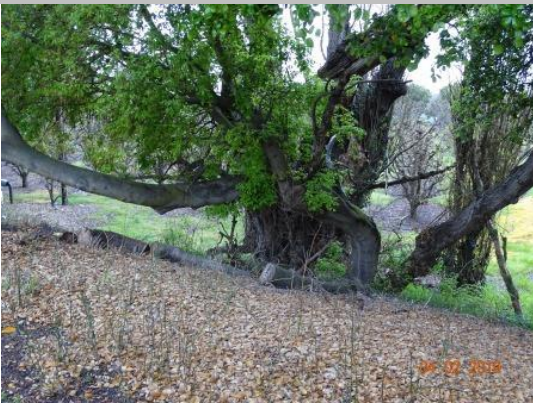
Photo 1 of 1 : FA_2019_RD0003_25_162_20190826_00144.jpg

View looking downslope at fallen tree limbs on the landside slope (Spring 2019).

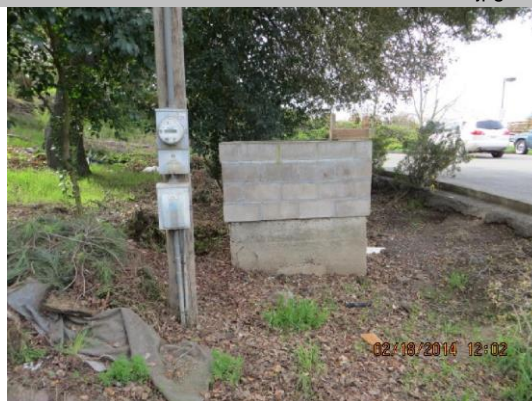
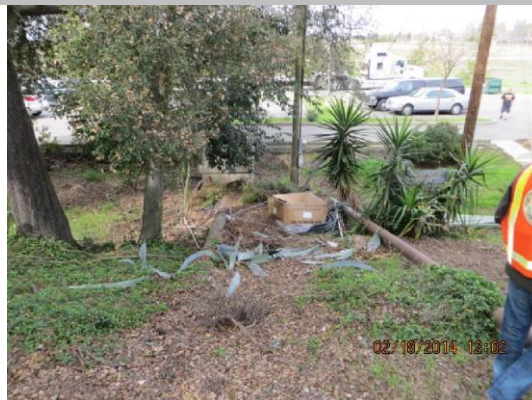
Comment Code						
Inspector Comment						
DS_ID:22290 FS_ID:30363 EP_NO: 665 Repair Type: Non-Urgent Crossing Status: Found UCIP Comments: Appears abandoned and if so should be done so properly. FIELD_STRUCT_DESC: 10-inch steel irrigation discharge pipe through the levee, invert elevation 2.8 feet below the crown. Pump on a pile structure in the river. 5-foot by 5-foot concrete distribution box at the landside (LS) toe with a meter pole. (Plans for the installation of a 10-inch, 10-gauge discharge pipe through the levee Permit No. 665, 1936 - C. T. Vollman). [Additional Reference(s): DWR Levee Log, 1993. USACE Sacramento O&M Manual 104, February 1960, (RM 26.62)]. FS Date: 2/18/2014

Concrete distribution box and meter on pole on LS toe.

Pipe and distro box visible at left side of photo.

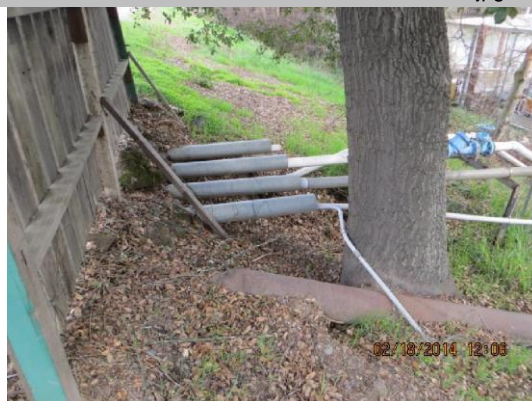
Photo 3 of 3 : UCIP_FA_2019_30363_55840.jpg

Item	DRAFT DWR UCIP Field Study			38.241867 °	38.241867 °	
				-121.516439 °	-121.516439 °	
DWR ID	22290					
Comment Code						
Inspector Comment						
DS_ID:22290 FS_ID:30363 EP_NO: 665 Repair Type: Non-Urgent Crossing Status: Found UCIP Comments: Appears abandoned and if so should be done so properly. FIELD_STRUCT_DESC: 10-inch steel irrigation discharge pipe through the levee, invert elevation 2.8 feet below the crown. Pump on a pile structure in the river. 5-foot by 5-foot concrete distribution box at the landside (LS) toe with a meter pole. (Plans for the installation of a 10-inch, 10-gauge discharge pipe through the levee Permit No. 665, 1936 - C. T. Vollman). [Additional Reference(s): DWR Levee Log, 1993. USACE Sacramento O&M Manual 104, February 1960, (RM 26.62)]. FS Date: 2/18/2014

Pipe visible in foreground next to oak.

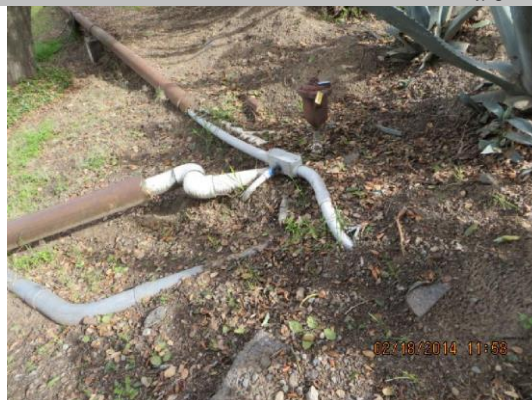
Photo 1 of 2 : UCIP_FA_2019_30352_55824.jpg

LM Start	11.62	Rating **	M	Issue No.	985	
LM End	11.62	Issue Type +	En	Location *		
Category	Supplemental			GPS Latitude/Longitude		
				Start	End	
Item	DRAFT DWR UCIP Field Study			38.241869 °	38.241869 °	
				-121.516436 °	-121.516436 °	
DWR ID	22320					
Comment Code						
Inspector Comment						
DS_ID:22320 FS_ID:30352 EP_NO: 16053 Repair Type: Non-Urgent Crossing Status: Found UCIP Comments: Annular space not grouted. FIELD_STRUCT_DESC: 1 of 4: 6-inch galvanized iron electrical conduit through the levee, 3 feet below the crown. 2-inch polyvinyl chloride (PVC) and 1-inch PVC electrical conduits sleeved through the 6-inch conduit. (Plans to install four 6-inch pipe casings through the levee authorized under Permit No. 16053, 1993 - Vollman-Clark Ranch, DCC Engineering Company, Inc). FS Date: 2/18/2014

Electrical conduit visible on LS slope.

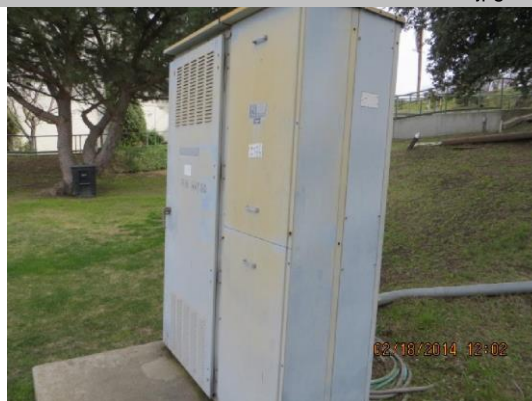
Photo 2 of 3 : UCIP_FA_2019_30353_55826.jpg

Electrical panel visible on LS toe.

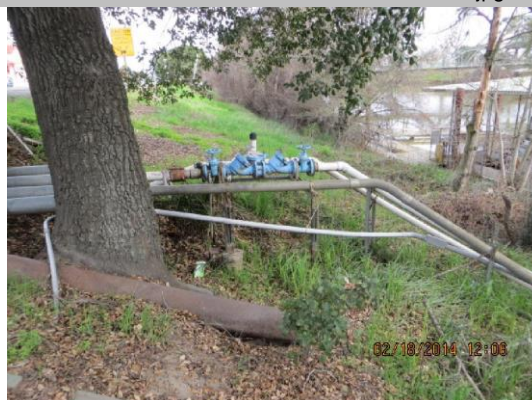
Photo 2 of 2 : UCIP_FA_2019_30356_55832.jpg

Blue backflow preventer with two shutoff valves visible on WS shoulder.

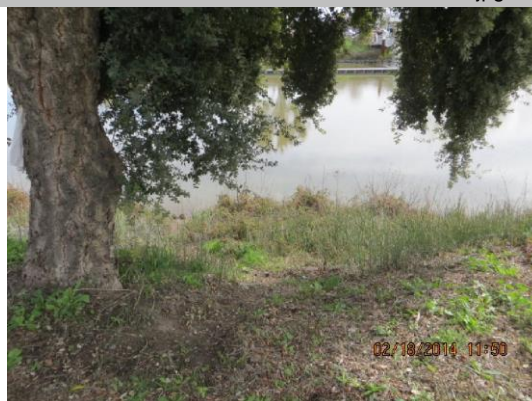
Photo 2 of 3 : UCIP_FA_2019_30345_55788.jpg

Item	DRAFT DWR UCIP Field Study			38.243865 °	38.243865 °	
				-121.514241 °	-121.514241 °	
DWR ID	22292					
Comment Code						
Inspector Comment						
DS_ID:22292						
FS_ID:30345						
EP_NO: N/A						
Repair Type: Non-Urgent						
Crossing Status: Found						
UCIP Comments: Depression over pipe at crown may indicate pipe is failing.						
FIELD_STRUCT_DESC: *ABANDONED* 12-inch welded steel irrigation discharge pipe through the levee, invert elevation 5 feet below the crown. Pipe was cut off and filled with concrete on the waterside (WS) slope. Pipe was cut off and left open on the WS end. (Plans to install a 7.5-horsepower angle mounted irrigation pump and a 12-inch, 10-gauge welded steel discharge pipe through the levee authorized under Permit No. 5428, 1966 - Grand Island Farms). [Additional Reference(s): DWR Levee Log, 1993, 10-inch pipe referenced. USACE Sacramento O&M Manual 104, February 1960, (RM 26.80), 10-inch pipe referenced].

Pipe visible just downstream and downhill from Cork Oak on WS shoulder.

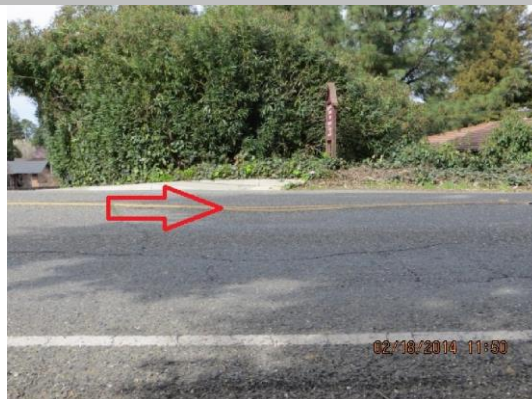
Photo 3 of 3 : UCIP_FA_2019_30345_55787.jpg

Depression over pipe alignment in crown/roadway.

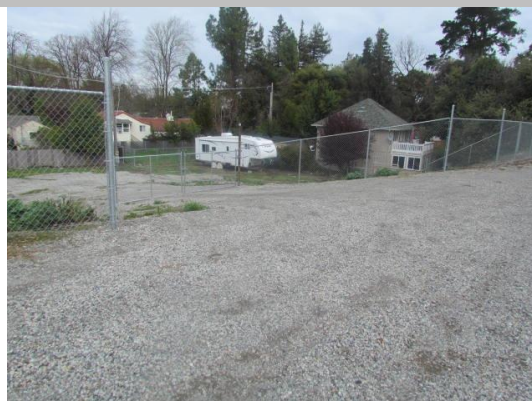
Photo 1 of 1 : FA_2019_RD0003_25_268_20190826_00171.jpg

LM Start	11.99	Rating **	M	Issue No.	268
LM End	11.99	Issue Type +	En	Location *	LS
Category	Earthen Levee			GPS Latitude/Longitude	
				Start	End
Item	Encroachments			38.246022 °	38.246022 °
				-121.512328 °	-121.512328 °
DWR ID	DWR_RD0003_02_s_2012_268				
Comment Code					
RA : Ramp					
Inspector Comment					
Landowner installed a new ramp without a board permit.

Looking north at ramp on landside slope.
